# Highview Elementary School Mechanical Distribution Replacement

## Designated Substance Audit Report

1040 Queensdale Avenue East, Hamilton, ON

February 22, 2024

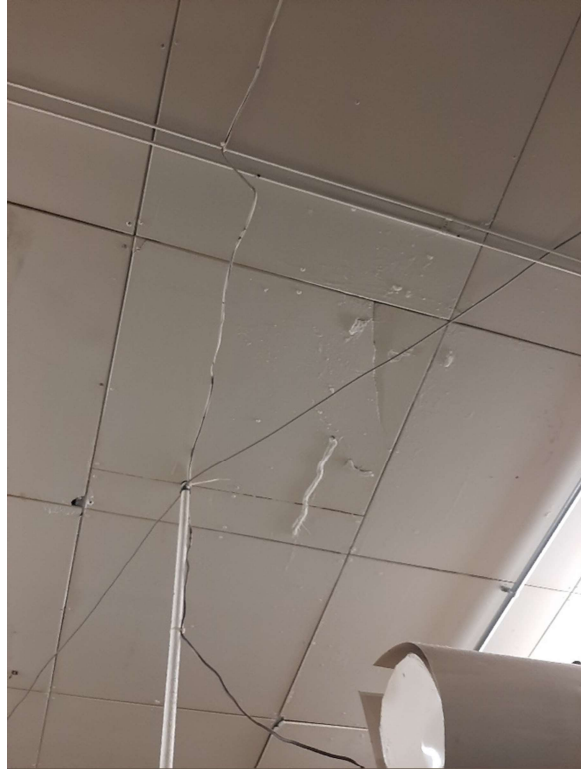
**Photograph No. 1 – Asbestos-containing cement (Transite) ceiling panels are present within the boiler room.**

ACMs were identified during the assessment. If these materials, including those deemed or suspected, will be disturbed, or will likely be disturbed, during building maintenance, renovations, construction, or demolition activities, they must be handled and disposed of in accordance with the procedures prescribed by O. Reg. 278/05.

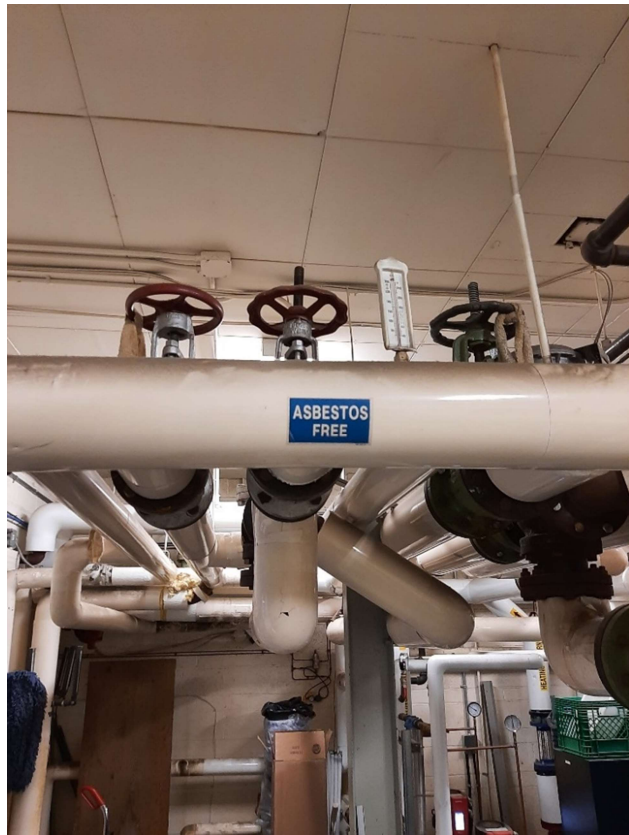
**Photograph No. 2 – Pipe straights and elbows consist of PVC over fiberglass and are not suspected of containing asbestos.**

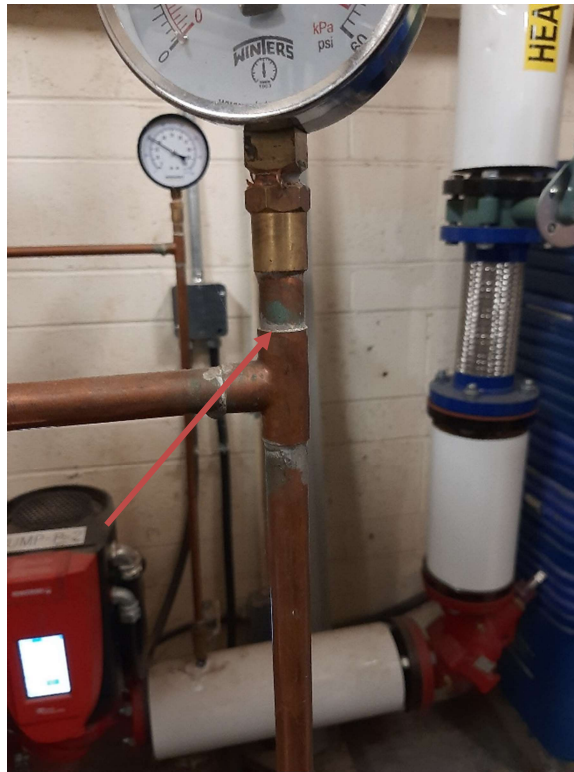
Photograph No. 3 – Suspect lead-containing solder on copper pipe connections was observed within the boiler room.

Lead-based paint, lead-containing paint, and suspect lead-containing solder on plumbing connections were identified. As such special requirements for the management, handling and disposal of lead-containing materials by the owner, constructor, contractor, sub-contractors and workers apply. The abatement contractor should consult Environmental Abatement Council of Canada's (EACC) *Lead Guideline for Construction, Renovation, Maintenance or Repair (October 2014)* for the procedures and methods required to remove and dispose of lead-containing materials.

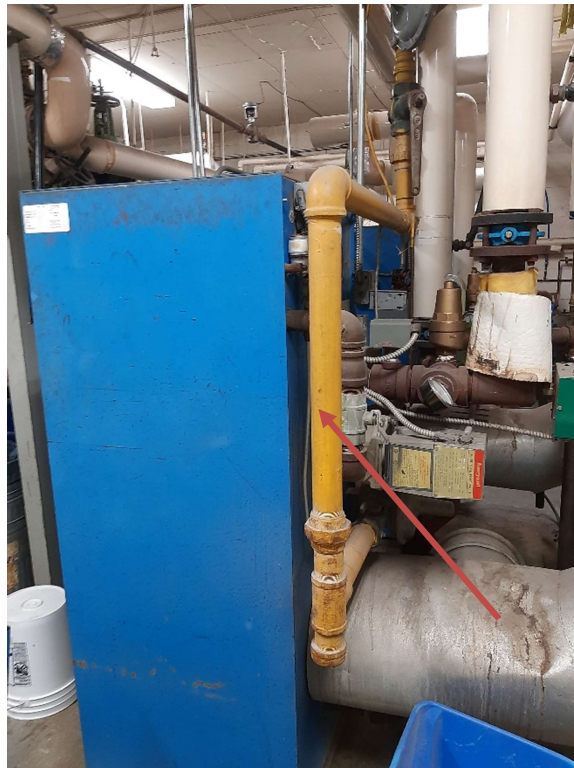
Photograph No. 4 – Yellow paint on the gas lines was sampled (LP03) and is lead-based.

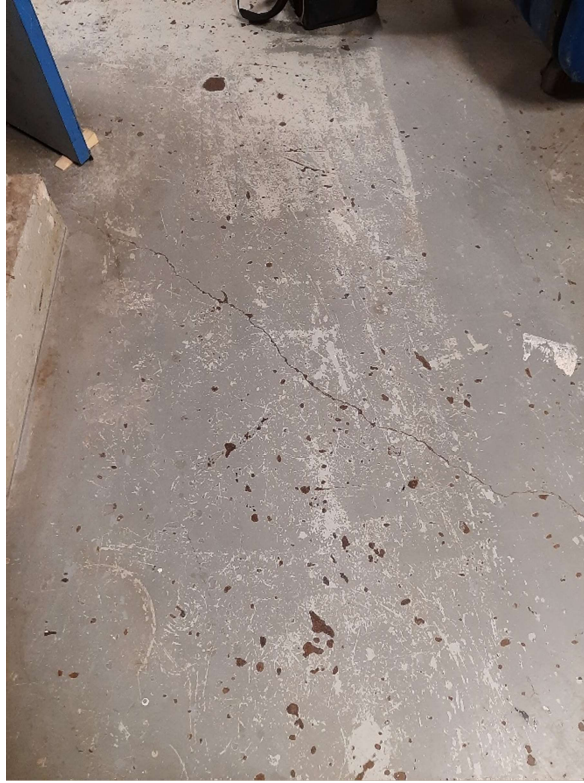
**Photograph No. 5 – The grey paint on the floor of the boiler room was sampled (LP02) and is lead-containing.**

<b>Lead-Containing Paint</b>	Boiler room	Grey Paint on Floors	In place management in accordance with EACC's Lead Guideline	Removal as required prior to maintenance, renovations, construction or demolition activities in accordance with EACC's Lead Guideline as a: Class 1, Class 2A, Class 3A, or a Class 3B Operation
<b>Low Level Lead-Containing Paint</b>	Boiler room	White Paint on Walls	None	General hygiene procedures during renovation activities: <ul style="list-style-type: none"> <li>• General dust control,</li> <li>• Washing of hands and face at on-site facilities,</li> <li>• No smoking, eating, chewing gum or drinking in the work area,</li> <li>• No abrasive blasting.</li> </ul>
<b>Lead</b>	Throughout Interior of Building on Plumbing Connections	Lead Solder on Copper Pipe	In place management in accordance with EACC's Lead Guideline	Removal prior to renovation/demolition activities in accordance with EACC's Lead Guideline as a: Class 1 Operation

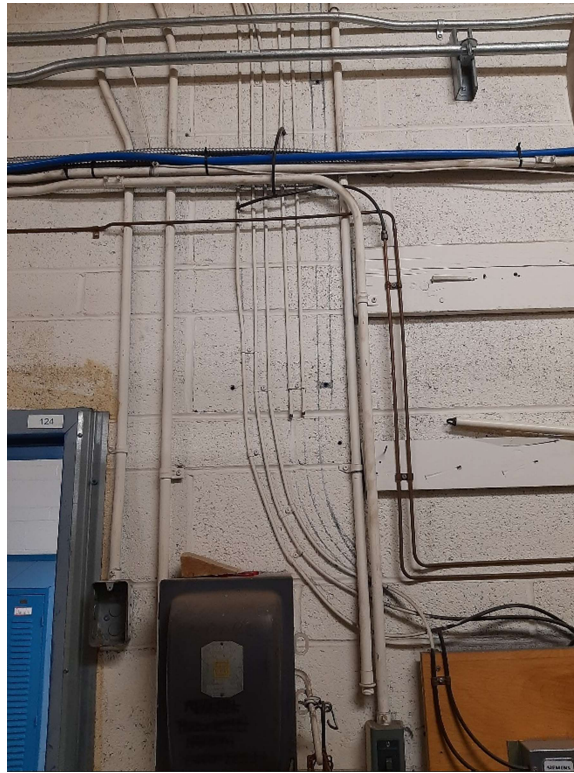
**Photograph No. 6 – The white paint on the walls of the boiler room was sampled (LP01) and is low level lead-containing. Several holes were present within the block walls of the boiler room and no evidence of vermiculite was observed.**

Low level lead-containing paint is also present and the following general procedures are recommended as a precautionary measure as per Environmental Abatement Council of Canada's (EACC) *Lead Guideline for Construction, Renovation, Maintenance or Repair (October 2014)*:

- General dust control;
- The washing of hands and face at on-site facilities;
- No smoking, eating, chewing gum or drinking in the work area; and,
- No removal of painted surfaces by means of abrasive blasting.
