Reference: **DRLHC-S-001-20-01 - Kellet Accessibility Ramp**
Investigation Report for Retaining Walls and Ramp
TAK Engineering Ltd., Project No.: 2021-07

TAK Engineering Ltd. conducted on January 2021 review of the existing site conditions of the main and side entrance ramps at the above noted address. The purpose of the inspection was to determine the condition of the elements and to provide the Region of Durham with recommendations for work.

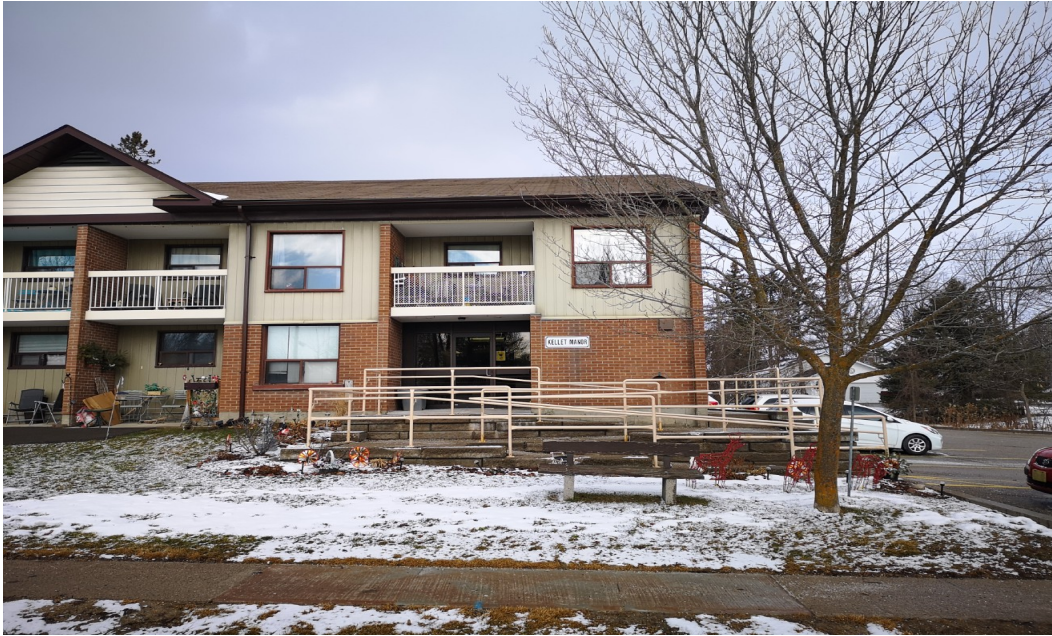
Fig. #1 General view of main entrance ramp.

1. **Main Entrance Ramp:** Remove and replace main entrance building retaining walls, concrete ramp, steps, and steel hand rails.
 - Build new ramp for disability access as a concrete walkway.
 - Construct architectural concrete retaining block walls of Risi Stone Inc. Stones, or approved equal.

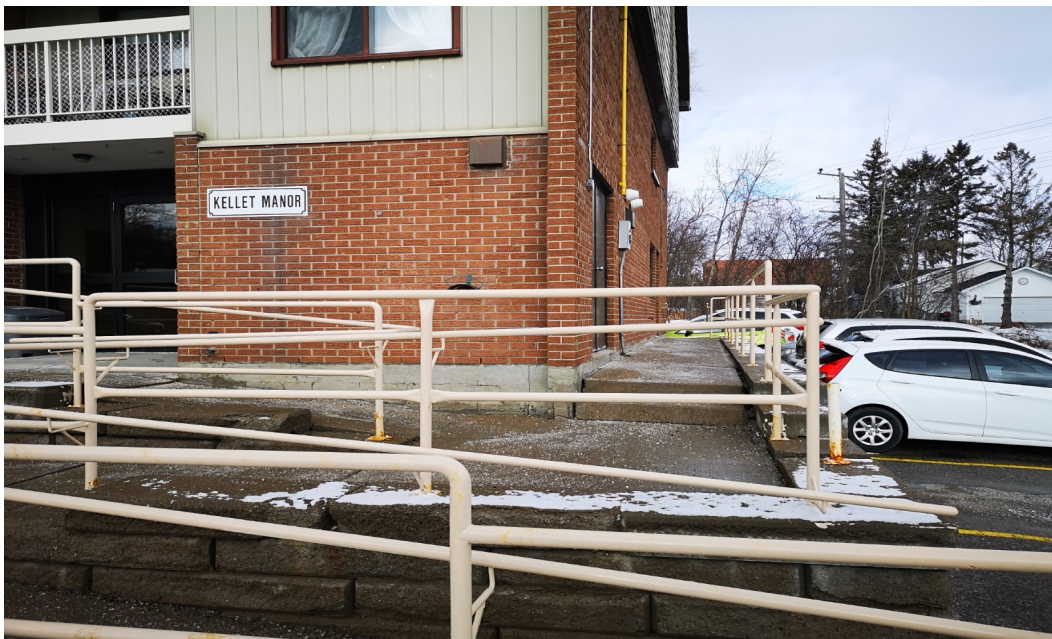
Fig. #2 General view of main entrance bottom part of the ramp.

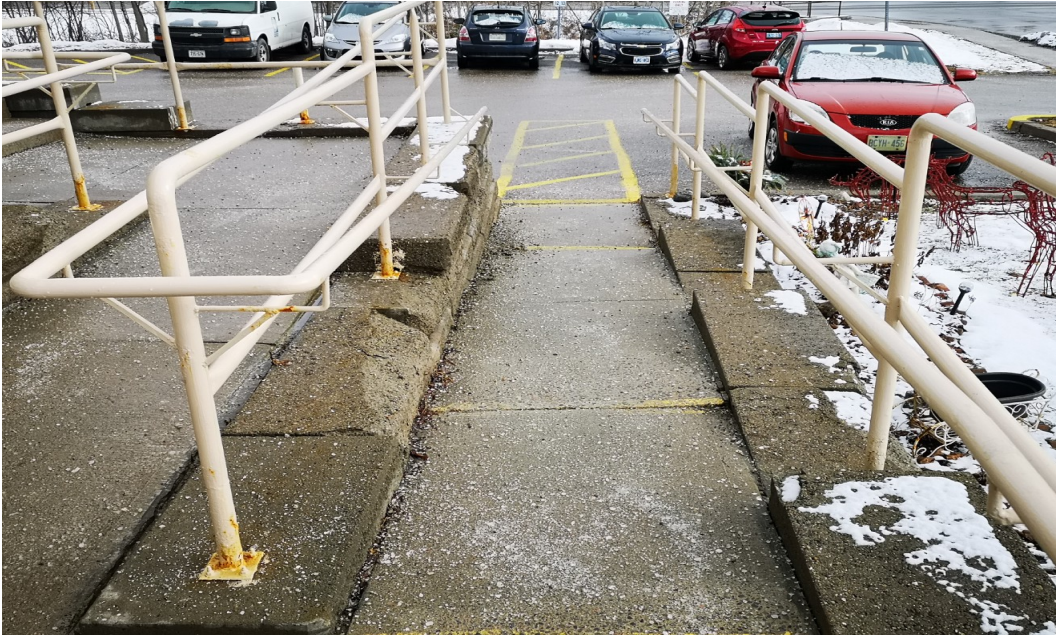
Fig. #3 Deteriorated retaining walls and guard rail base plates.

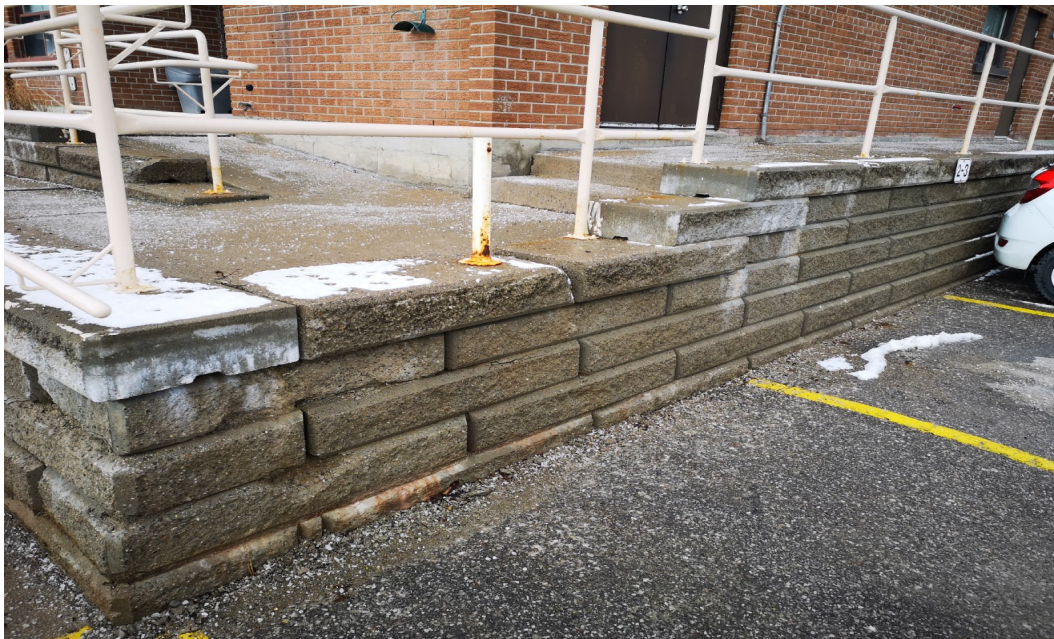
Fig. #4 Another view of deteriorated retaining wall.

- Retaining concrete block wall supports walkway and runs parallel to the building. Concrete slabs were inclined and needs replacement, see Fig. #7.
- Retaining wall was tilted, out of plumb, coping blocks were deteriorated. See Figs. #4 and #8.
- Wall was leaking at the base; see Fig. #4. It appears that wall drainage is not working.

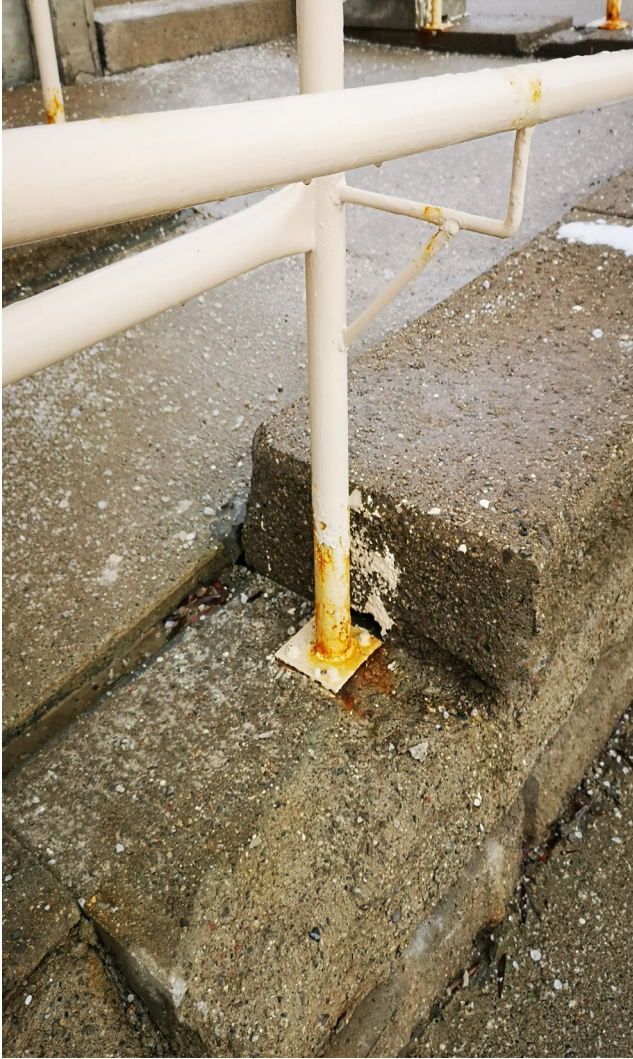
Fig. # 5 Deteriorated ramp and side retaining stones. Fig. # 6 Deteriorated side retaining stones.
Note stone are uneven.

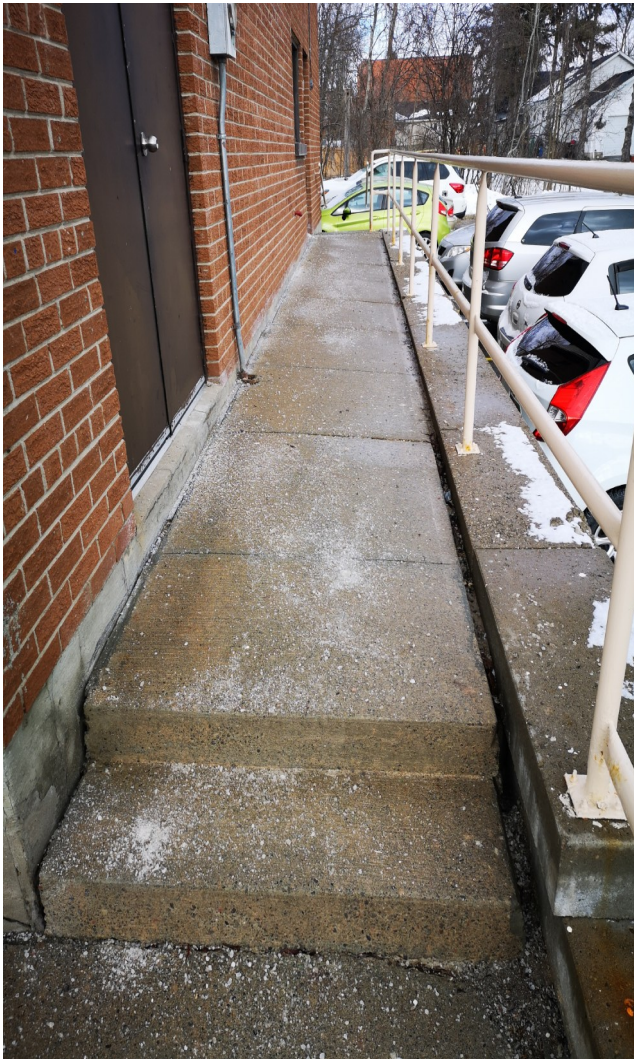
- Concrete slab steps leading to the building side entrance were tilted; see Figs. #8 and #9.
- The steps were placed directly on asphalt walkway without foundation; see Fig. #9.
- There was a gap between concrete slab and retaining wall; see Fig. #7.
- The guard rail secured to the top of the existing retaining wall was in poor condition; see Figs. #7 and #8. Base plates were heavy corroded.
- The guard rail was out of plane at places; see Fig. #7.

Fig. #7 Side retaining wall supporting walkway. Note leaning concrete.

2. Side Entrance Ramp: Remove and replace concrete walkway including retaining wall:

- Build new retaining wall similar to existing architectural concrete block wall, Risi Stone Inc. stones.
- Construct new concrete walkway.
- Construct new concrete stone steps.
- Install new guard rails meeting Ontario Build Code 2012 requirements.

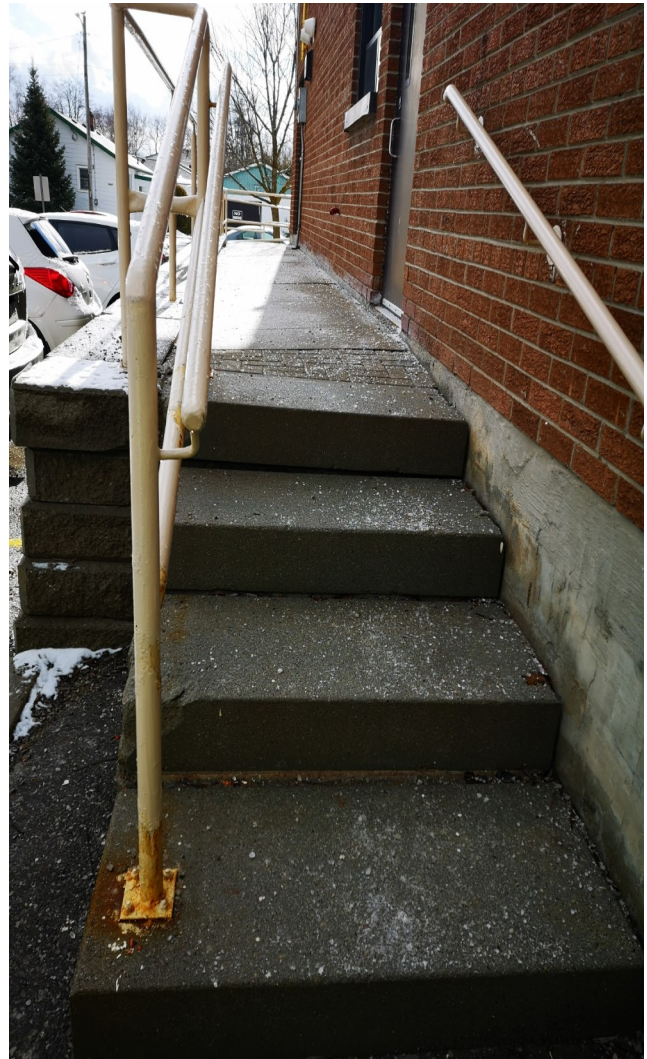
Fig. #8 Side retaining walkway and the steps. Note leaning concrete steps and corroded guard rail base.

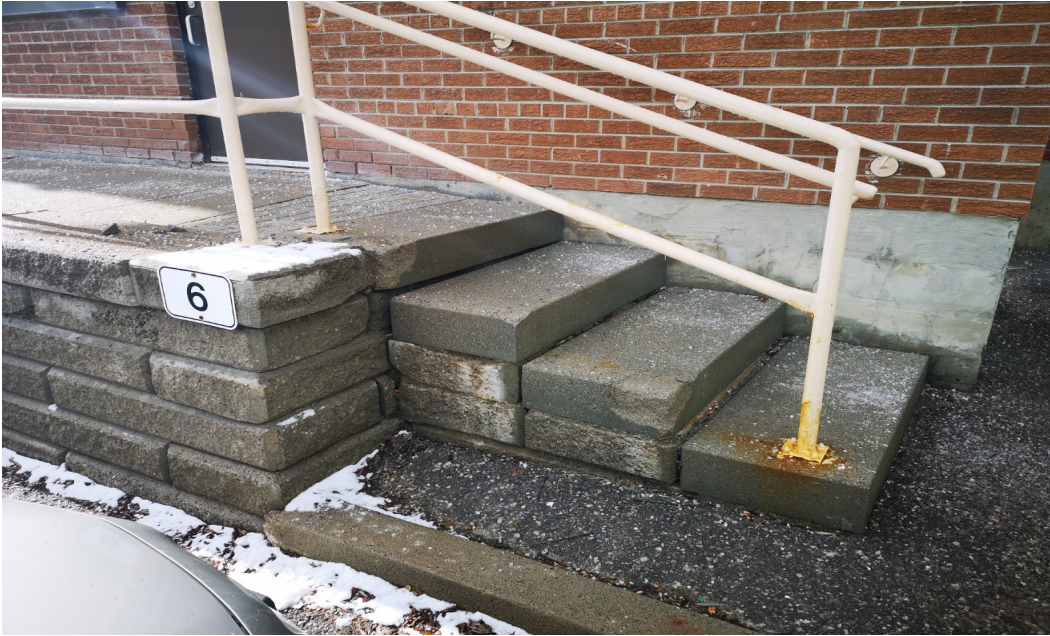
Fig. # 9 View of steps. Note deteriorated guard rail.
