March 28, 2011

DESIGNATED SUBSTANCE SURVEY

327 Kellet Street, Port Perry, Ontario

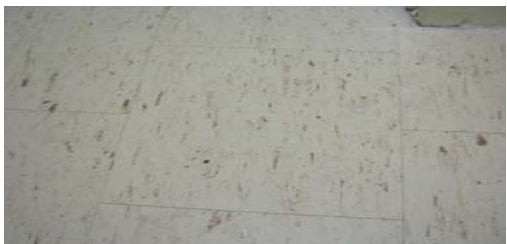
- Beige 30 cm x 30 cm vinyl floor tiles with brown flecks (Samples 4A-C) were found to contain “Trace” amounts to 0.25% chrysotile asbestos. Approximately 3 square meters of the tile was observed in the Elevator Mechanical Room on the Second Floor. The term “Trace” and 0.25% indicates an asbestos content below the regulated 0.5% asbestos (by dry weight) and is therefore, not considered to be an ACM under O. Reg. 278/05.

Area	Level	Location	Material & Description	Est. Qty*	Units	Condition	Friable Yes/No	Accessibility	Sample #	% Asbestos and Type	Photographs	Recommended Actions
Interior	Attic Space	Air vents	Black tar	2	Square meters	Good	No	Moderate	1A-C	None Detected	  Photograph 1	No action required.
Exterior	All	Balcony - perimeter of concrete deck	White caulking	28	Meters	Good	No	High	2A-C	None Detected	  Photograph 2	No action required.
Party Room (Kitchen and Closet), Second Floor Laundry Room and Stairwells	All	Floor	White 30cm x 30cm vinyl floor tiles with green flecks	31	Square meters	Good	No	High	3A-C	None Detected	  Photograph 3	No action required.
Second Floor Elevator Room	Second Floor	Floor	Beige 30cm x 30cm vinyl floor tiles with brown flecks	3	Square meters	Good to damaged	No	Moderate	4A-C	TRACE to 0.25% chrysotile

Photograph 4	No action required.
Unit 201	Second Floor	Floor	Light beige 30cm x 30cm vinyl floor tiles with brown streaks	37	Square meters	Good	No	High	5A-C	None Detected	  Photograph 5	No action required.

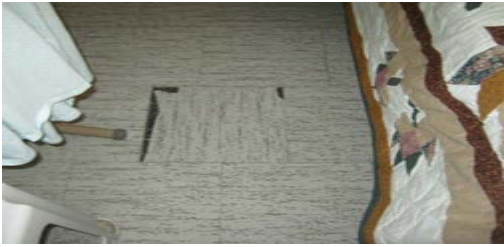
- Beige 30 cm x 30 cm vinyl floor tile with brown spots (Samples 6A-C) were found to contain 4.5% chrysotile asbestos. At least 50 square meters of this floor tile is present in each of the Residential Units. However, newer non-ACM flooring materials (i.e. newer non-ACM vinyl floor tiles, “peel and stick” floor tiles, carpet, etc.) were observed in various Residential Units. These materials have likely been installed directly on-top of the original asbestos-containing vinyl floor tiles. As such, within the Residential Units, all secondary layers of flooring concealed by newer materials should be presumed to be asbestos-containing. The ACM floor tiles are considered to be non-friable and were observed to be in good condition

Area	Level	Location	Material & Description	Est. Qty*	Units	Condition	Friable Yes/No	Accessibility	Sample #	% Asbestos and Type	Photographs	Recommended Actions
Tenant Spaces	All	Floor (suspected under new tiles and carpet in all Residential Units)	Beige 30 cm x 30 cm vinyl floor tiles with brown spots.	103	Square meters	Good	No	High to Low	6A-C	4.5% chrysotile

- Asbestos-containing vinyl floor tile present in good condition throughout the Residential Units may be managed in place. If the floor tiles become damaged or prior to activities which may impact the floor tiles, they should be removed following Type 1 procedures, as outlined in O. Reg. 278/05, provided non-powered hand tools and water are used. Any secondary layers of concealed flooring materials should be presumed to be asbestos-containing until laboratory analysis proves otherwise.

Photograph 6	Manage in Place or, if the tiles become damaged or if they will be impacted by future renovation/demolition activities, remove following Type 1 Asbestos Abatement Procedures, as outlined in O. Reg. 278/05.
Throughout	All	Select walls and ceilings	Drywall joint compound	888	Square meters	Good	No	High	7A-C	1.5% chrysotile

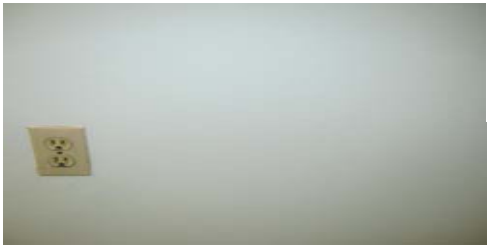
- Drywall wall joint compound (Samples 7A-G) was found to contain 1.5% chrysotile asbestos. Approximately 900 square meters of the material are present on select walls and ceilings throughout the Site. The joint compound is considered to be a non-friable material was noted to be in mostly in good condition with areas of minor damage (i.e. at corners) in several of the units.

- Asbestos-containing drywall joint compound present in good condition may be managed in place. If the joint compound becomes damaged, or prior to activities which may impact the joint compound, it should be removed following Type 1 (if less than 1 square meter) or Type 2 procedures (if greater than 1 square meter), as outlined in O. Reg. 278/05.

Photograph 7	Manage in Place or, if the drywall joint compound will be impacted by future renovation/demolition activities, remove following Type 1 (if less than 1 square meter) or Type 2 (if more than 1 square meter) Asbestos Abatement Procedures, as outlined in O. Reg. 278/05.

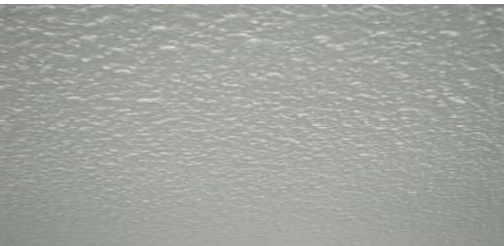
- White texture coat (Samples 8A-C) was found to contain 2.8% chrysotile asbestos. Approximately 260 square meters of texture coat was observed on the ceilings of the Common Areas and within the Residential Units. Texture coat ‘overspray’ present on attic access hatches, walls, on duct work, etc. should also be considered to be asbestos-containing. Texture coat is considered to be a friable ACM and was generally observed to be in good condition.

Throughout	All	Select ceilings	Texture coat	260	Square meters	Good	Yes	High	8A-C	2.8% chrysotile

- Asbestos-containing texture coat present in good condition on the ceilings of the Common Areas and within the Residential Units and on the walls of the Second Floor Laundry Room, may be managed in place. If the texture coat becomes damaged, or prior to activities which may impact the texture finish (including areas with texture coat 'overspray'), it should be removed following Type 2 (if less than 1 square meter) or Type 3 procedures (if greater than 1 square meter), as outlined in O. Reg. 278/05.

Photograph 8	Manage in Place or, if the texture finish will be impacted by future renovation/demolition activities, remove following Type 2 (if less than 1 square meter) or Type 3 (if more than 1 square meter) Asbestos Abatement Procedures, as outlined in O. Reg. 278/05.
Maintenance Office and Second Floor Laundry Room	All	Wall	Texture coat	38	Square meters	Good	Yes	High	9A-C	1.4% chrysotile

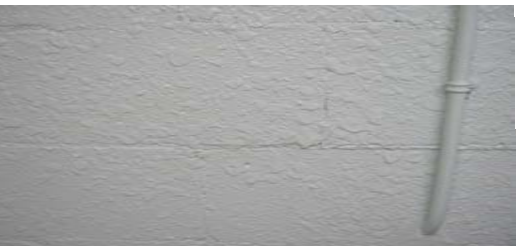
- Painted white texture coat was found to contain 1.4% chrysotile asbestos. Approximately 16 square meters of the material is present over the concrete block walls in the Laundry Room on the Second Floor. Texture coat is considered to be a friable ACM and was observed to be in good condition.

Photograph 9	Manage in Place or, if the texture finish will be impacted by future renovation/demolition activities, remove following Type 2 (if less than 1 square meter) or Type 3 (if more than 1 square meter) Asbestos Abatement Procedures, as outlined in O. Reg. 278/05.

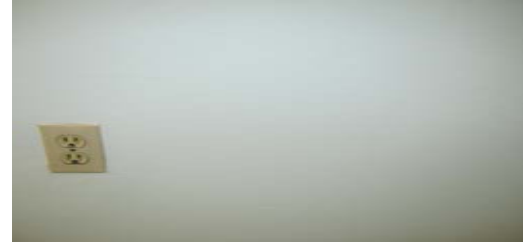
Area	Level	Location / Substrate	Colour & Description	Est. Quantity*	Accessibility	Sample #	% Lead	Photographs	Recommended Actions
Common Areas	Throughout	Drywall walls	Teal paint	Unknown	High	LP-1	0.055%

<p>Photograph 1</p>	Measures must be taken to ensure the TWAE for lead is not exceeded. Refer to conclusions and recommendations for further details.
Exterior - Balconies	Throughout	Concrete deck	White paint	Unknown	High	LP-2	0.0067%	  <p>Photograph 2</p>	Measures must be taken to ensure the TWAE for lead is not exceeded. Refer to conclusions and recommendations for further details.
Maintenance Areas	Throughout	Concrete floors	Grey paint	Unknown	Moderate	LP-3	0.1%	  <p>Photograph 3</p>	Measures must be taken to ensure the TWAE for lead is not exceeded. Refer to conclusions and recommendations for further details.
Attic Space	Attic	Mechanical vents	Grey paint	Unknown	High	LP-4	0.064%	  <p>Photograph 4</p>	Measures must be taken to ensure the TWAE for lead is not exceeded. Refer to conclusions and recommendations for further details.

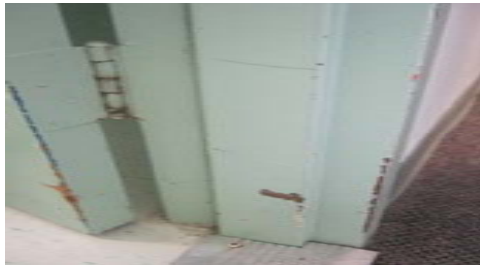
Area	Level	Location / Substrate	Colour & Description	Est. Quantity*	Accessibility	Sample #	% Lead	Photographs	Recommended Actions
Common Areas	All	Metal and wood trim	Dark teal	Unknown	High	LP-5	0.087%

Photograph 5	Measures must be taken to ensure the TWAE for lead is not exceeded. Refer to conclusions and recommendations for further details.
