March 28, 2011

DESIGNATED SUBSTANCE SURVEY

327 Kellet Street, Port Perry, Ontario

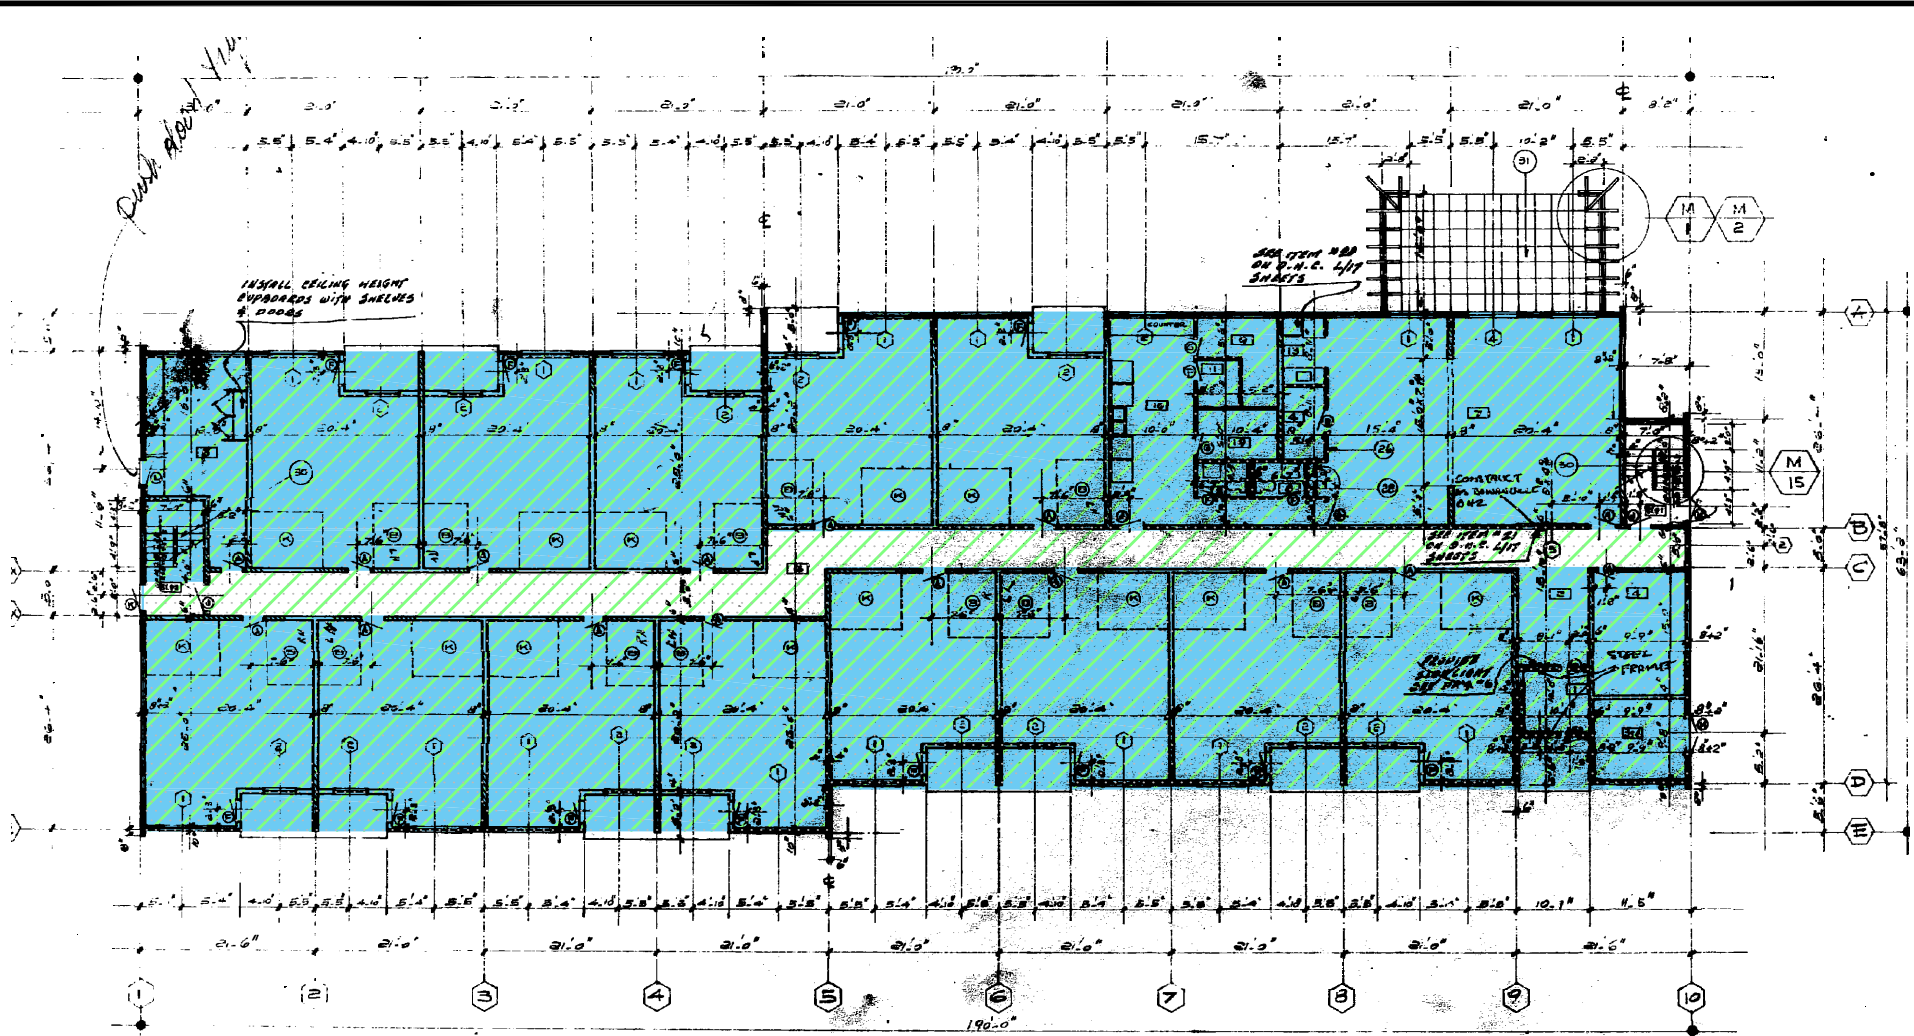
PROJECT		Designated Substances Survey 327 Kellet Street Whitby, Ontario	
TITLE			
SAMPLE LOCATIONS PLAN: GROUND FLOOR			
PROJECT No. 10-1187-0256(8000)		FILE No. MA01	
DESIGN		SCALE	NTS. REV.
CADD	PJV Mar. 2011	FIGURE 1	
CHECK			
REVIEW
